NATIONAL TRANSPORTATION SAFETY BOARD

MATERIALS LABORATORY FACTUAL REPORT

Report No. 19-061

Place : Catalina Island, California
Date : June 17, 2019
Vehicle : Robinson R-44
NTSB No. : WPR19FA175
Investigator : Maja Smith AS-WPR

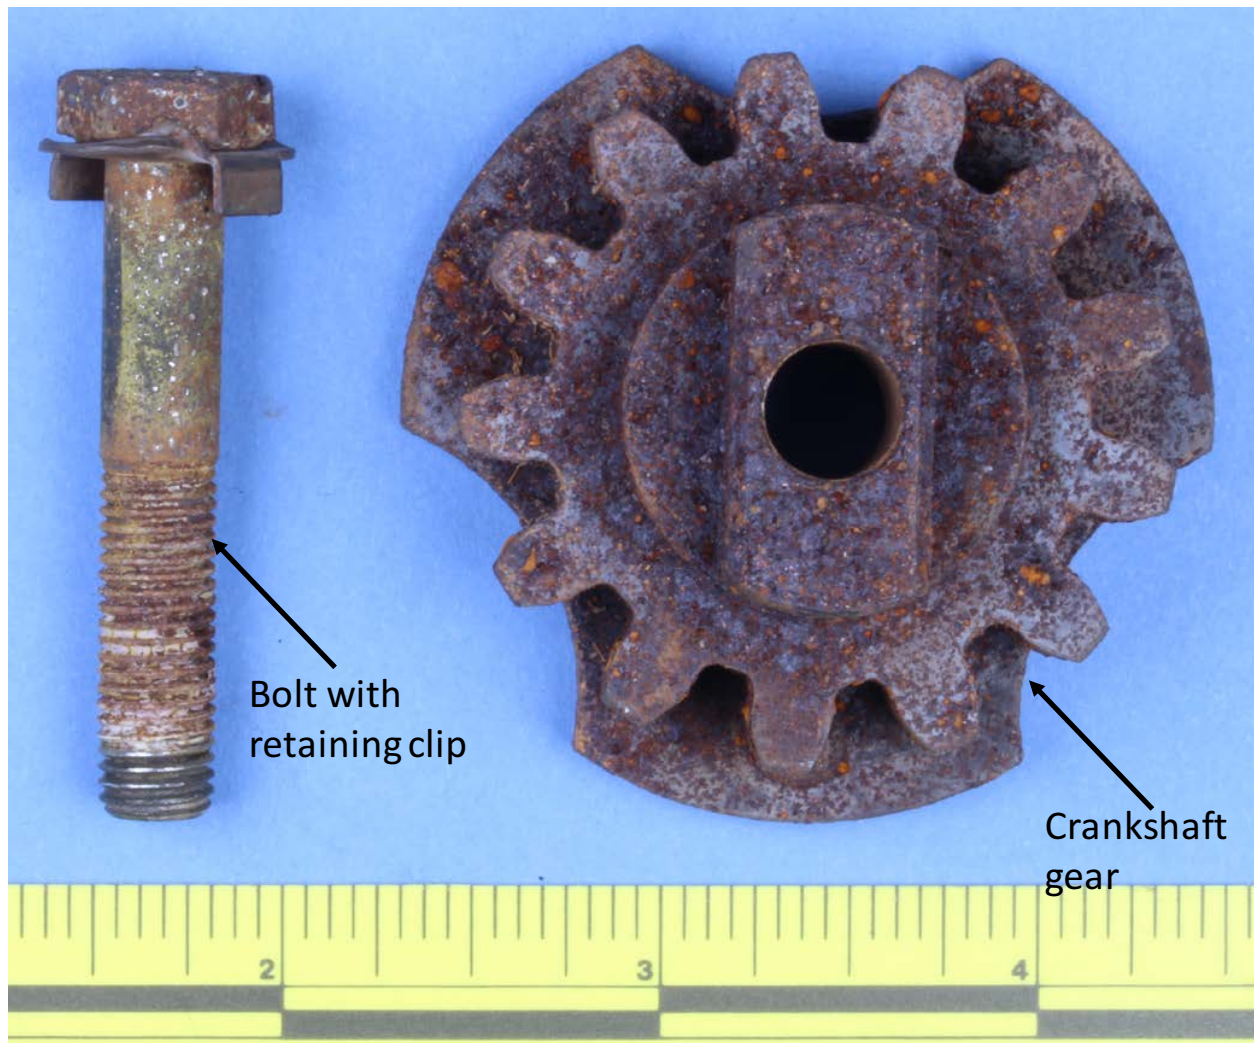
The as-received crankshaft gear with fractured dowel pin and associated mounting bolt/retaining clip are shown in Figures 1 and 2. The components exhibited a uniform layer of corrosion product on all surfaces. The purpose of this report is to document the fracture mode of the dowel pin.

Figure 1 The as-received crankshaft gear with fractured dowel pin and associated mounting bolt/retaining clip.

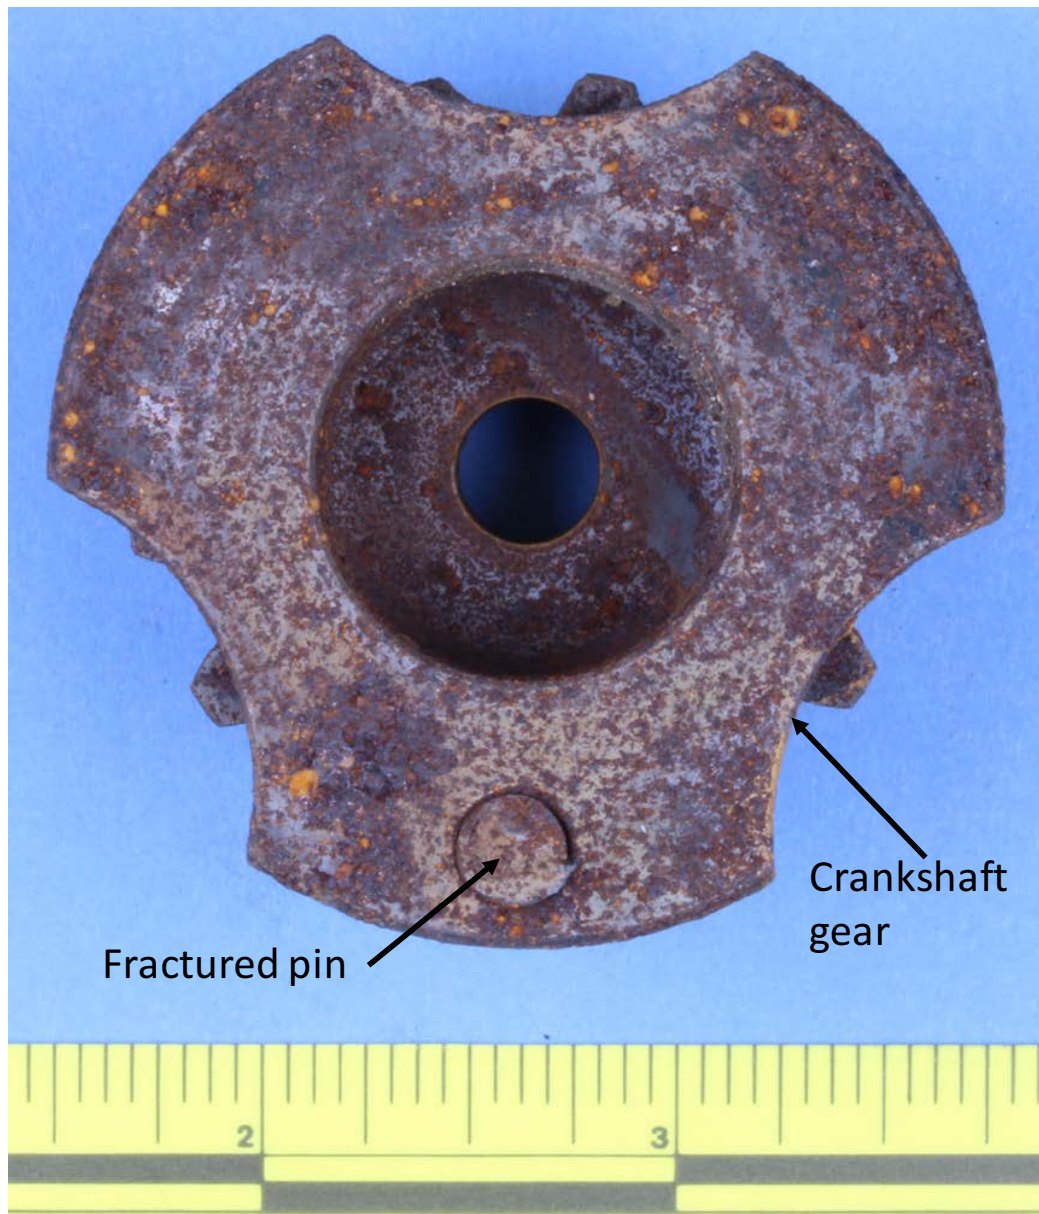
Figure 2 Image of the reverse side of the crankshaft gear showing the fracture surface of the dowel pin.

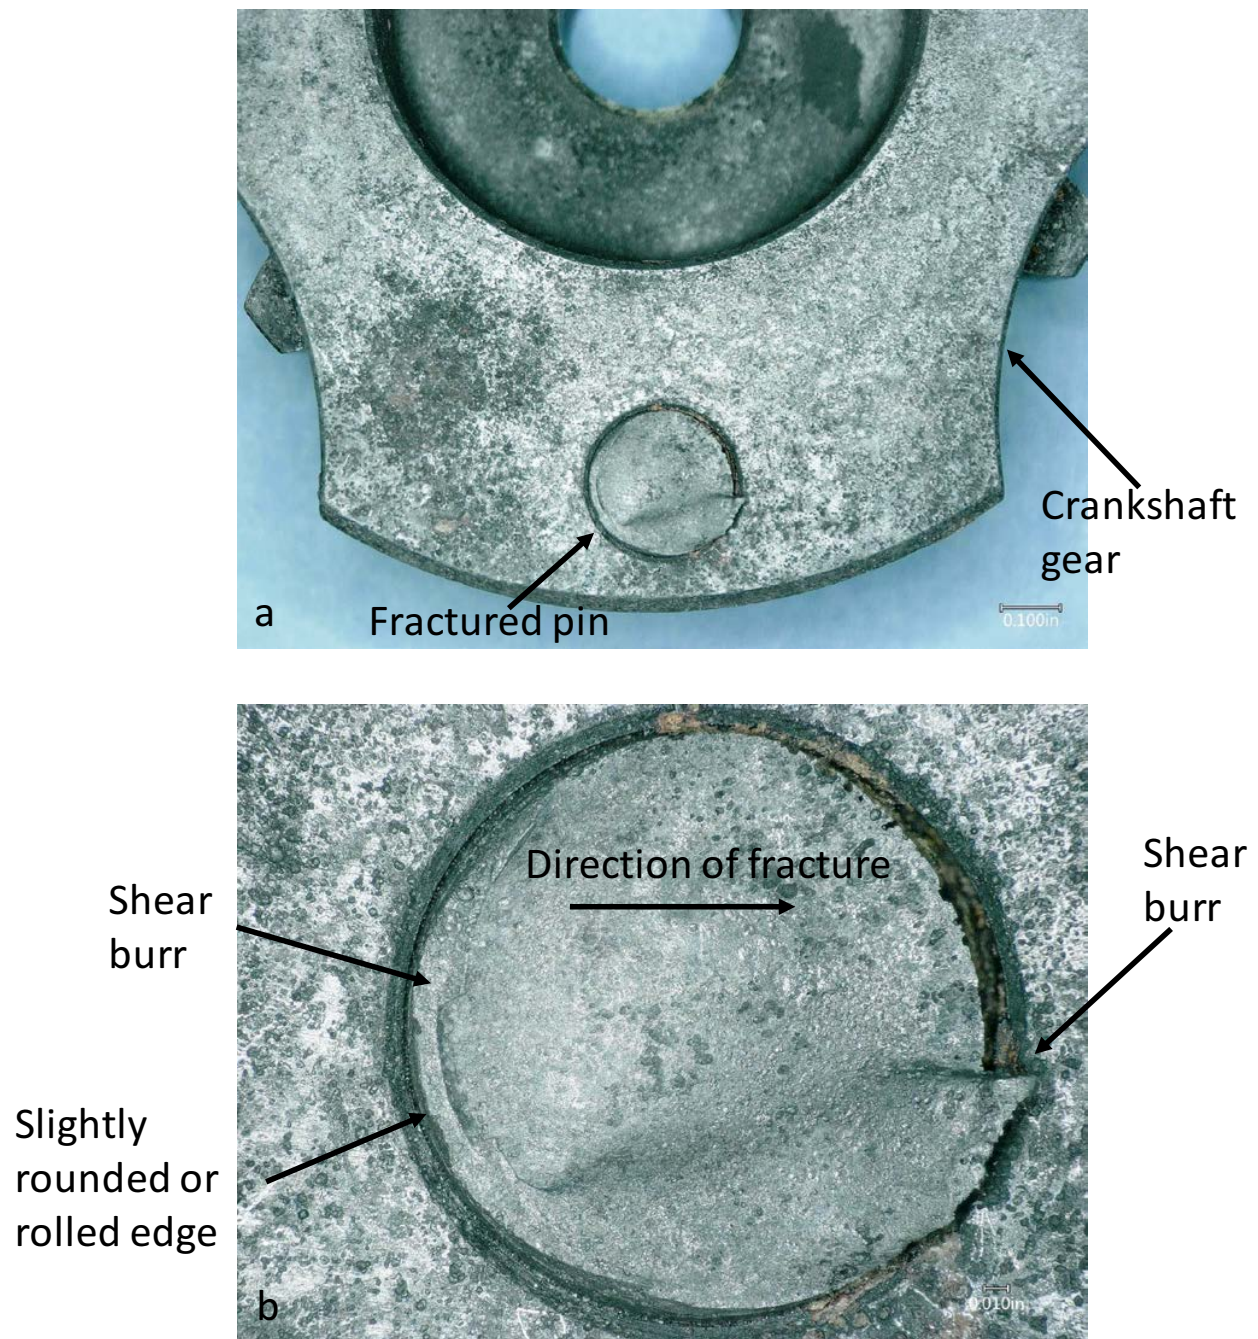
Close views of the fracture surface of the dowel pin after removal of the corrosion product are shown in Figures 3-5. Figures 3b and 4 shows the presence of shear burrs on the fracture surface as well as a rounded leading edge. The direction of fracture is also indicated.

Figure 3 Close digital-microscope top-down images of the fracture surface of the dowel pin. The surfaces have been cleaned with Evaporust. Key fracture features are identified.

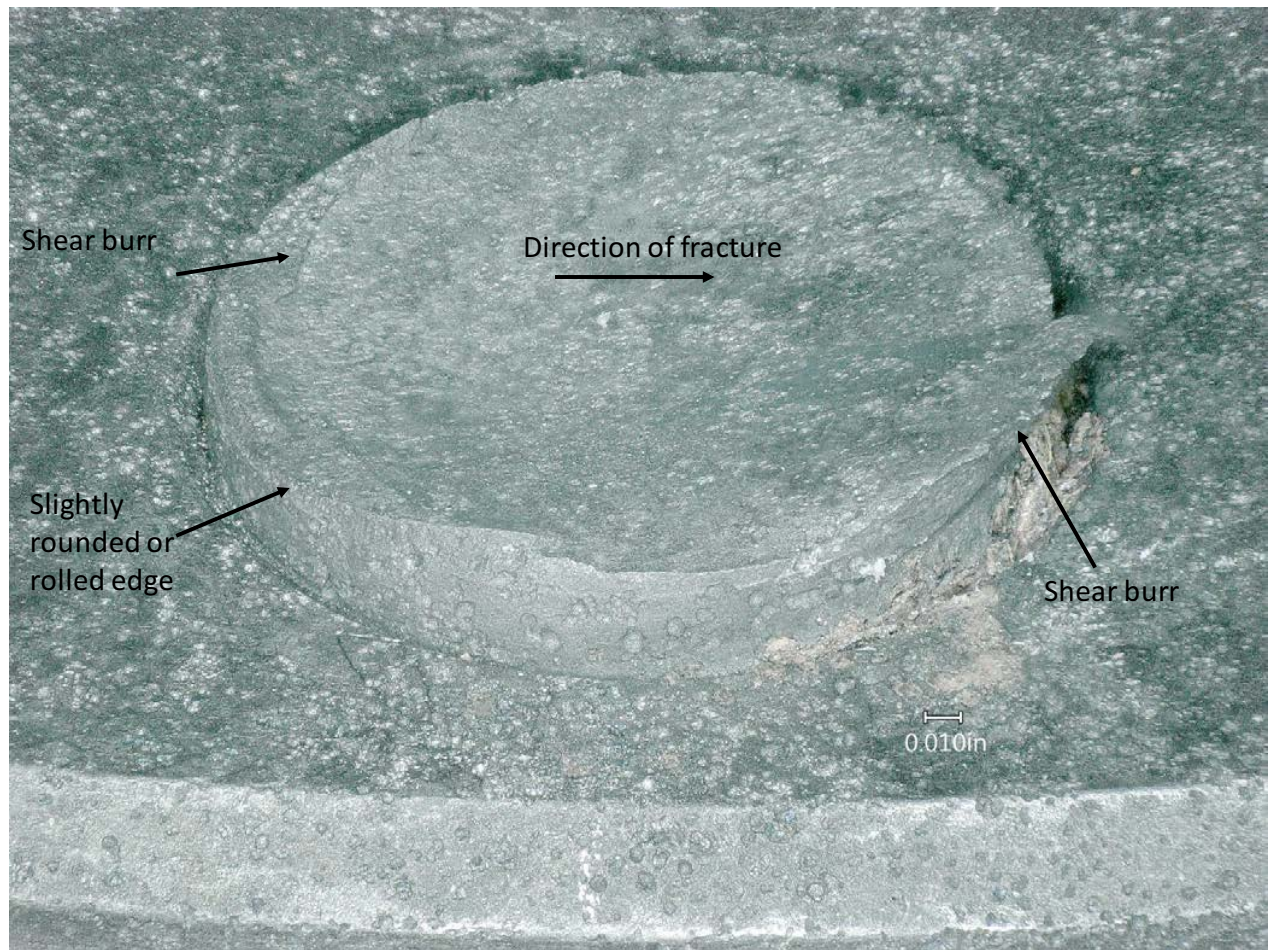
Figure 4 Close digital-microscope oblique-image of the fracture surface of the dowel pin. The surfaces have been cleaned with Evaporust and fine pits are evident. Key fracture features are identified.

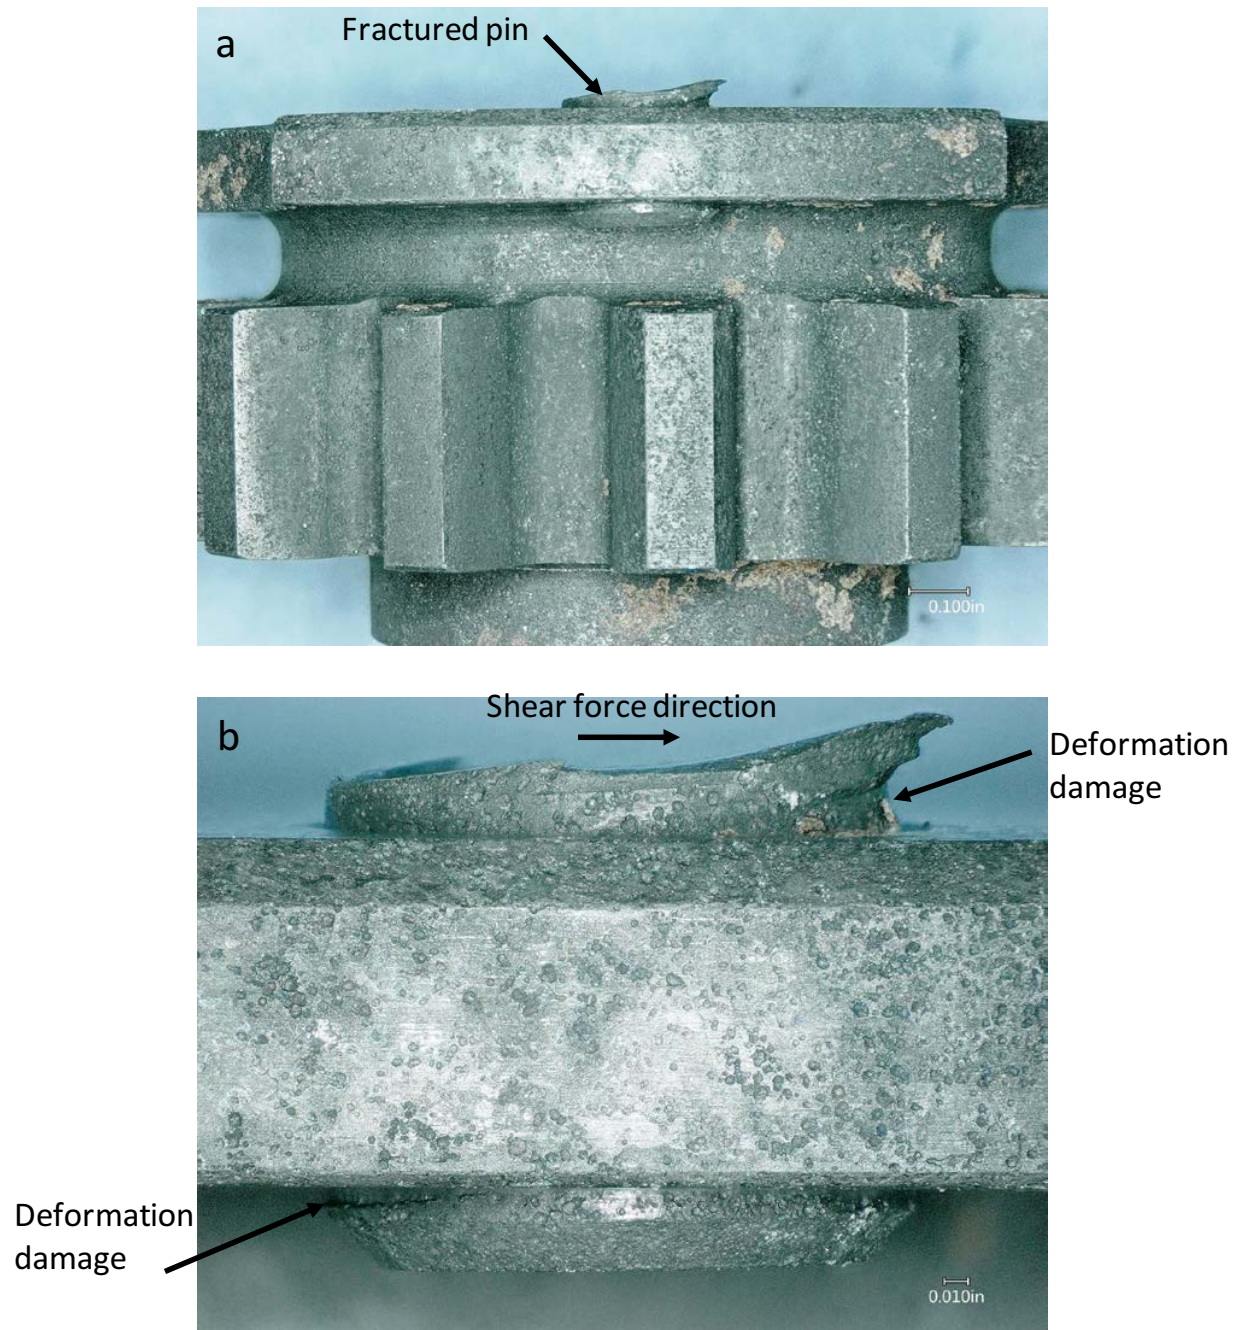
A profile view of the fractured dowel pin is shown in Figure 5. Deformation damage to the shank of the down pin is shown in Figure 5b. This deformation damage is consistent with application of a shearing force in the direction indicated in the figure.

Due to the extent of material loss due to corrosion, the micro-fracture mode could not be documented. However, the macro-fractographic features are consistent with shear overstress fracture in the direction indicated in Figure 5b.

Figure 5 Close digital-microscope profile-views of the fracture surface of the dowel pin. The surfaces have been cleaned with Evaporust and fine pits are evident. Key fracture features are identified.
